CERTIFICATE OF APPROPRIATENESS

Property: 7706 Rockhill St., Lot 4, Block40, Glenbrook Valley Subdivision. The property includes a historic single-family ranch home with a 2 car attached garage, situated on a 7,475 square foot lot.

Proposal: Alteration – Replace seven original windows and three original doors.

HPO File No. 160329

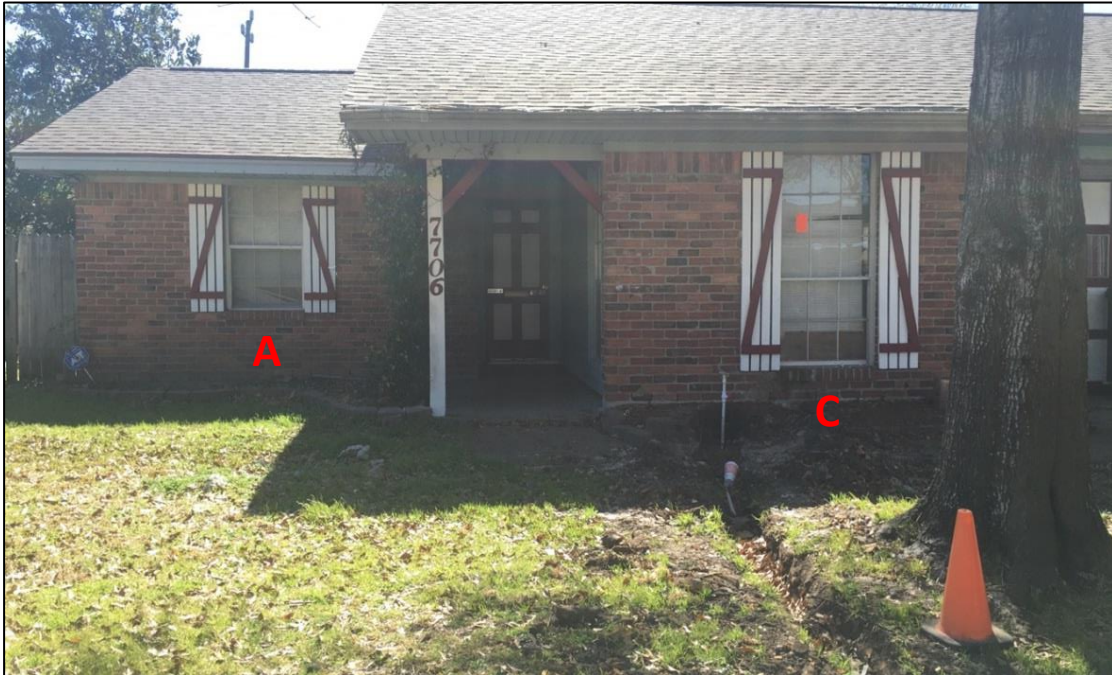
EXISTING FRONT WINDOWS A, C

Windows/Doors: Windows: The existing residence features 9-over-6 aluminum sash windows on the front portion. These windows are 3'-0" x 6'-2". The windows on the west side of the house are 6-over-6 aluminum sash windows that are 3'-0" x 4'-6". The existing windows are damaged beyond repair due to differential settlement. They no longer open or function properly.

The applicant proposes to replace the existing aluminum windows with replacement vinyl windows. All proposed windows will feature a 1-over-1 lite pattern (to avoid interior muntins) and will be installed in the existing opening. The sizes of the windows will not be altered. The front windows will be 3'-0" x 6'-2", to match existing, while the west side windows will be 3'-0" x 4'-6", to match existing. See photos and drawings for more detail.

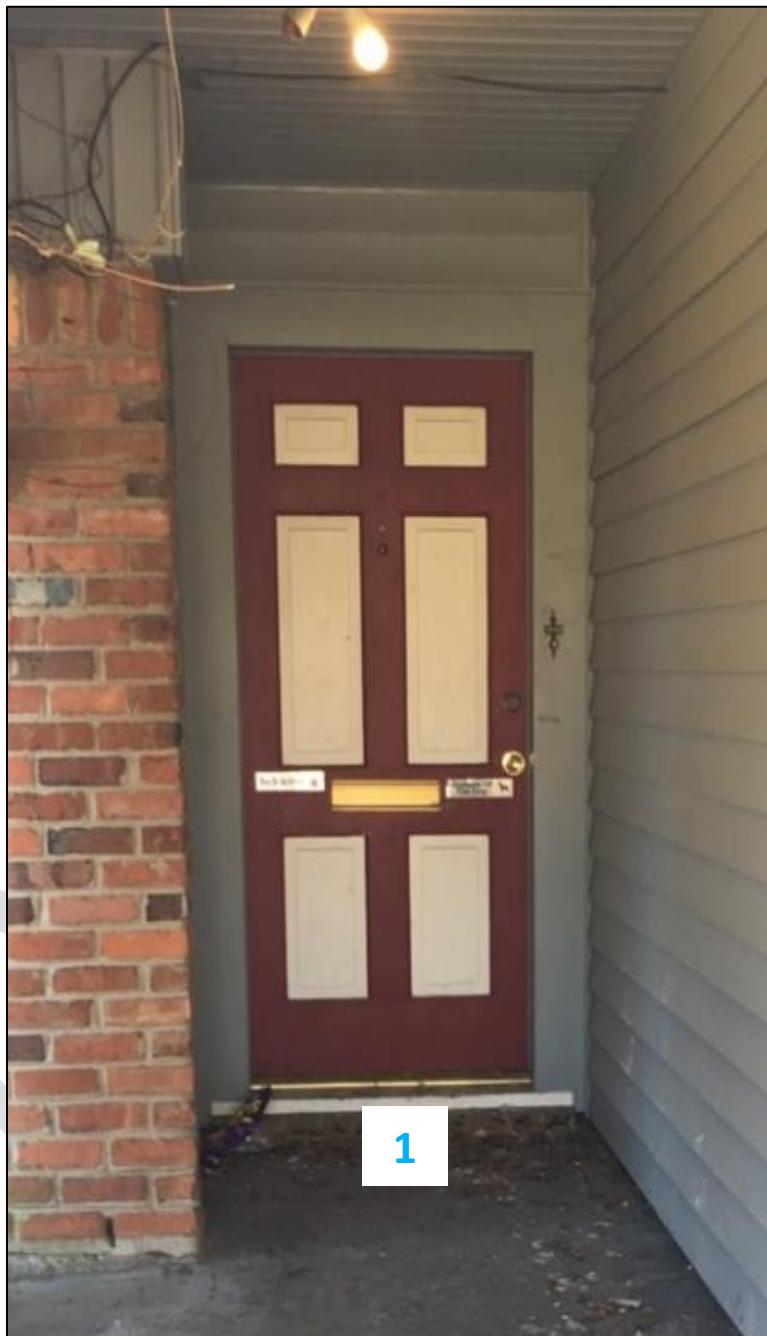
FRONT DOOR 1

- ☐ ☒ ☐ (1) The proposed activity must retain and preserve the historical character of the property;
The proposed new windows retain the historical character of the existing property; however the proposed door is not compatible with the character of the property. Additionally, our online preservation manual notes 'Victorian-style beveled glass doors' as being incompatible. The existing door is original to the structure and should be retained and not replaced

Doors: The existing residence features a six paneled wood front door with no lites. The two east wood side doors each feature two panels.

- ☐ ☒ ☐ (7) The proposed replacement of missing exterior features, if any, should be based on an accurate duplication of features, substantiated by available historical, physical or pictorial evidence, where that evidence is available, rather than on conjectural designs or the availability of different architectural elements from other structures;
The proposed new windows retain the historical character of the existing property; however the proposed door is not compatible with the character of the property. The existing door is original to the structure and should be retained and not replaced, if the door is damaged beyond repair, the new door should be similar to the existing door.

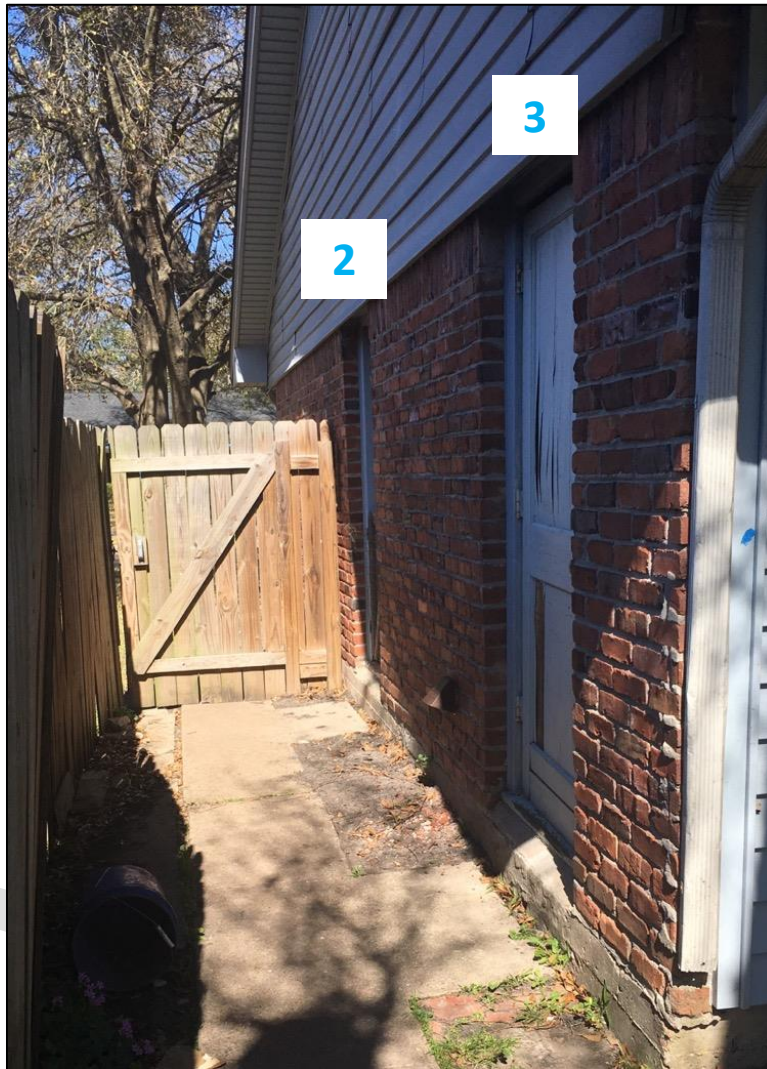
EAST SIDE DOORS 2, 3

The proposed front door features several panels and a large oval light with leaded and beveled glass. Although the two east side doors look damaged, no proposed replacement doors have been submitted. See drawings and photos for more detail.
